LANDSLIDES AND RELATED FEATURES

OF THE IRVINE, KY. QUADRANGLE

William F. Outerbridge

OPEN FILE MAP 82-51 (F-1)

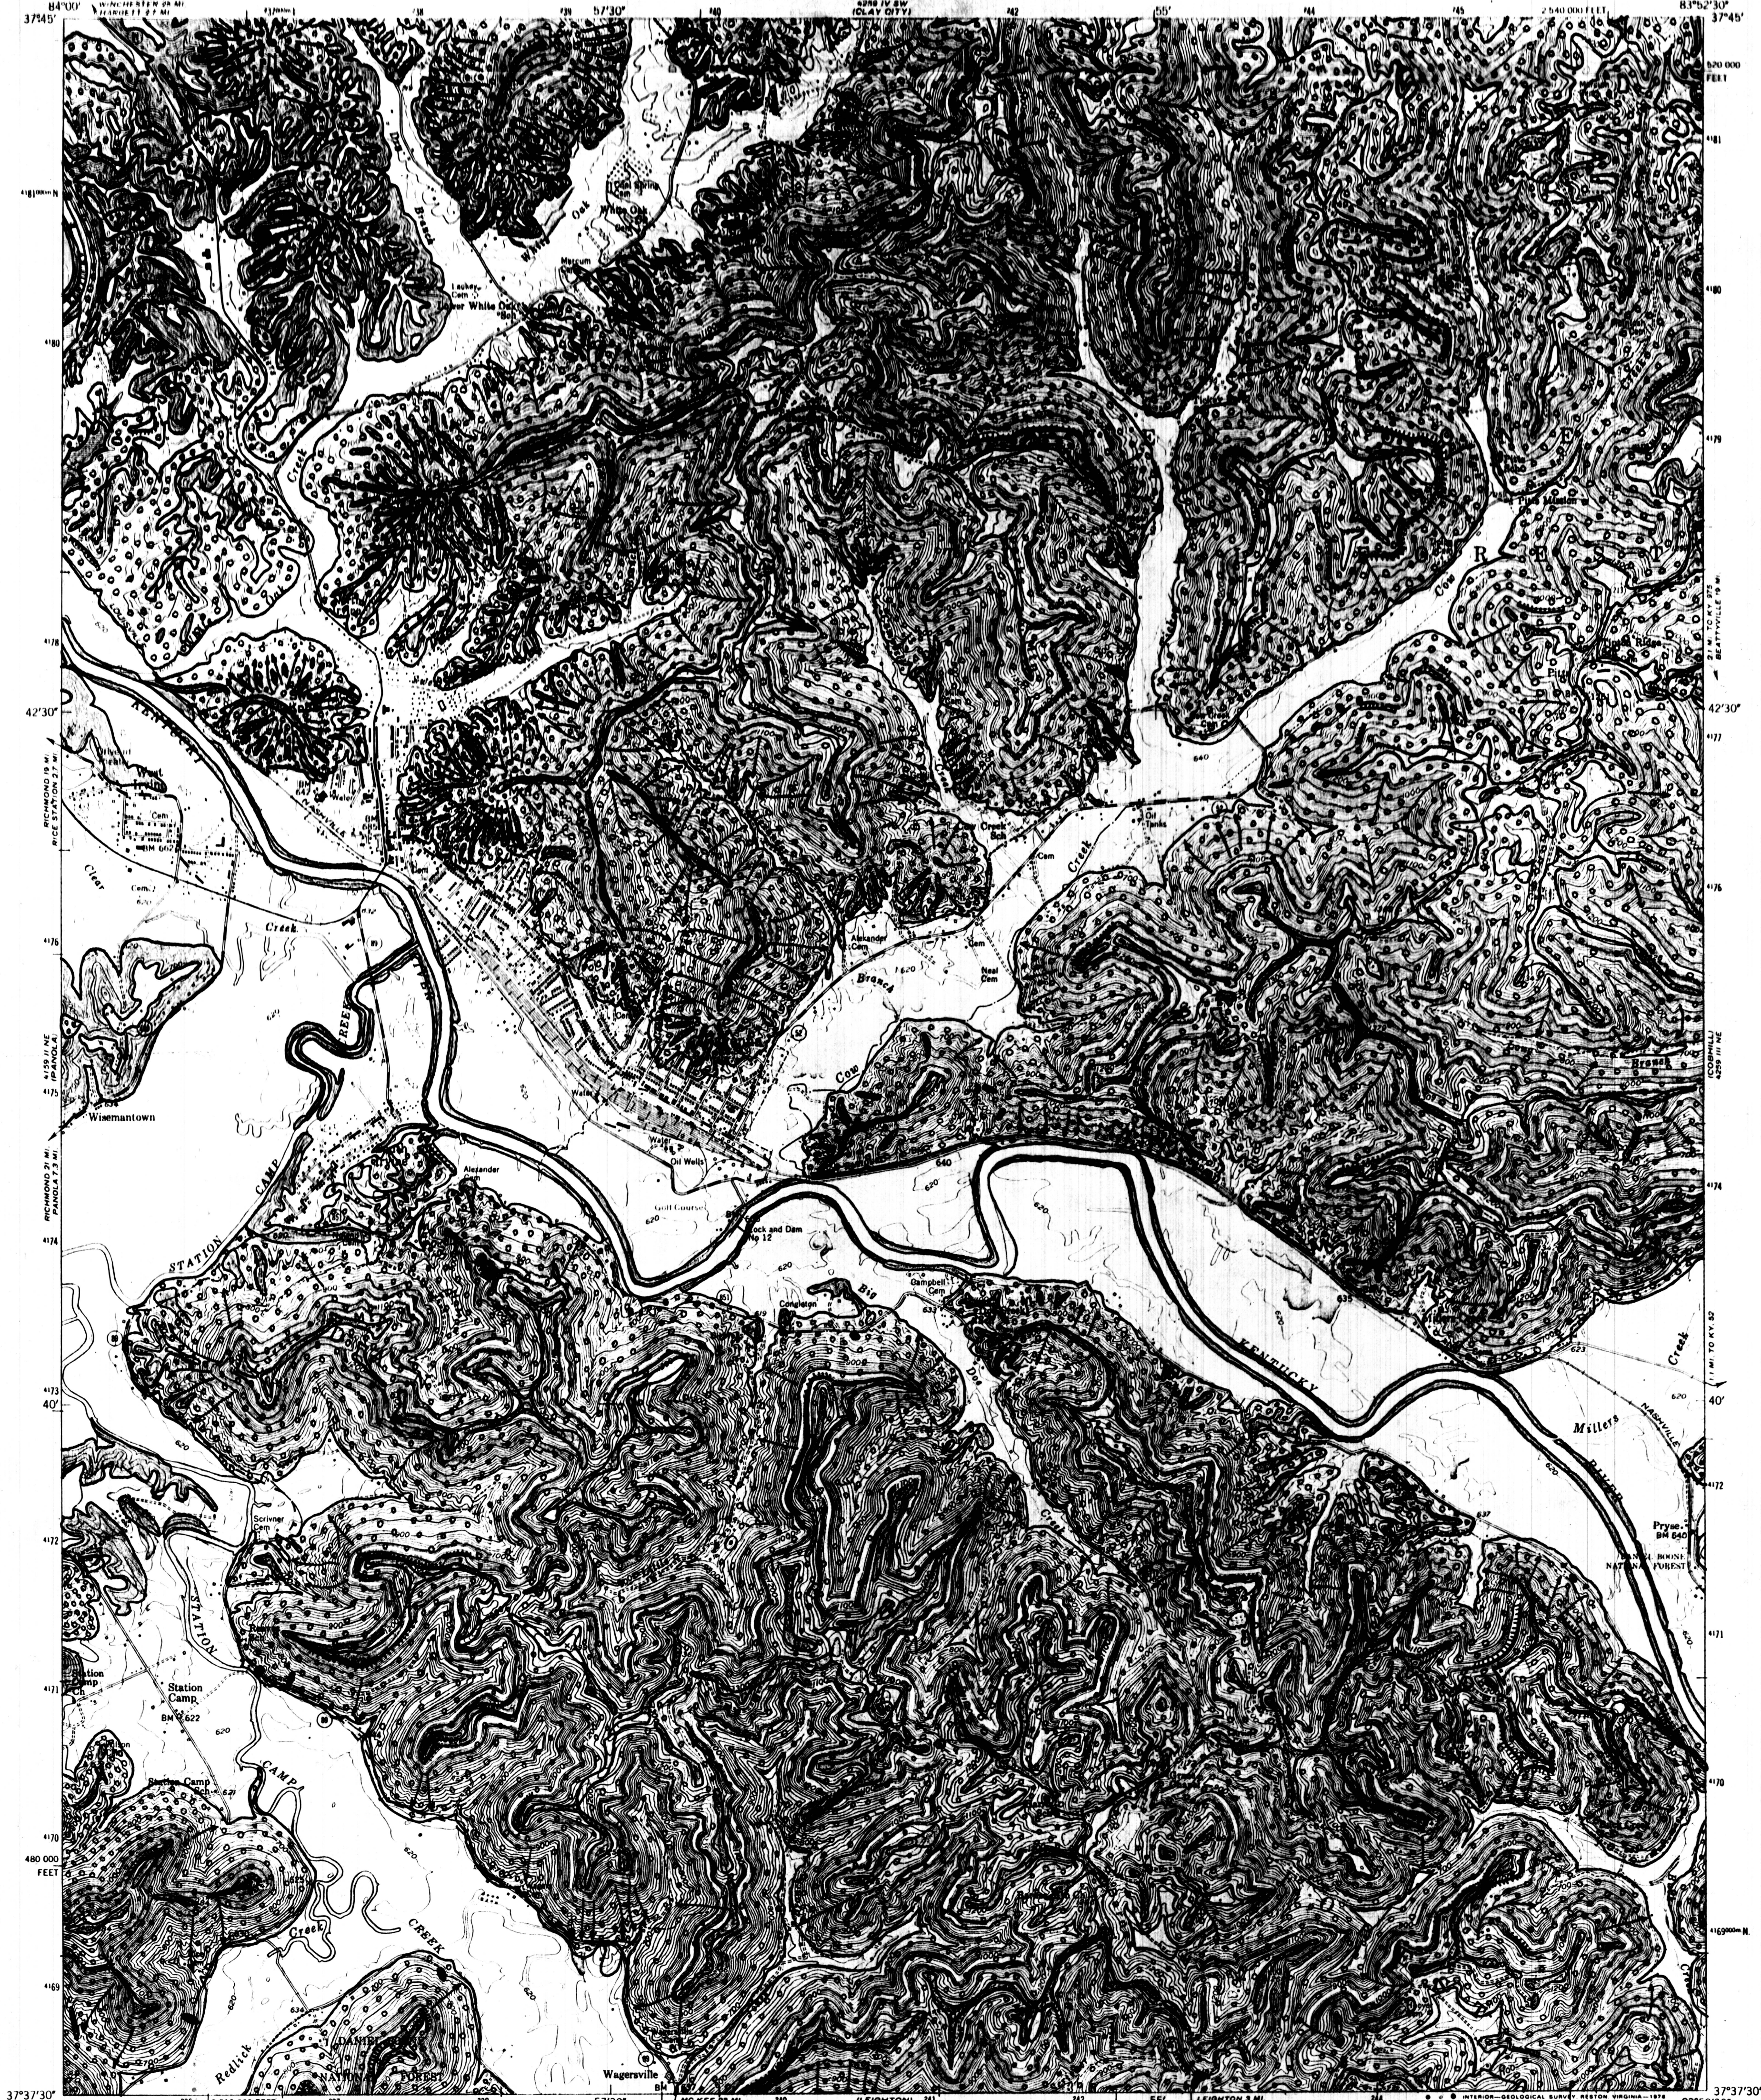
Landslides and related features interpreted from aerial photographs:

ACTIVE OR RECENTLY ACTIVE LANDSLIDE
Complex landslide composed of earthflow, debris slide, earth and rock slump. Identified from historical records, and from scars, debris and other field evidence. Ground extremely unstable; sliding accelerated by excavation, loading and changes in drainage conditions. May include areas with several active slides too small to be shown separately. Questioned where doubtful.

OLD LANDSLIDE
Area of extensive hummocky ground caused by earthflow and earth and rock slump. Lacks clear evidence of active sliding. Relatively stable in natural, undisturbed state, generally not affected by small structures properly sited in areas away from the edge of the toe; can be reactivated by extensive, rapid excavation, loading, and changes in ground water and surface water conditions. Area of old landslide probably includes recent ones not identified from field evidence or otherwise documented. Upslope boundary of landslide generally defined by modified scarp, but downslope (toe) may be gradational and not well defined. Questioned where doubtful.

COMBINATION LANDSLIDE
Area of recent and old slides in which individual slides are not identified.

COLLUVIAL SLOPE
Valley wall along major streams with slope as steep as 40° (85%); stony, clayey silt soil up to 50 ft. (15 m) thick; commonly buttressed by a terrace or bench at the toe of the slope; very susceptible to sliding by cutting of toe area, removal of terrace or bench, and overloading; slide commonly activated without apparent cause.

COLLUVIAL SLOPES WITH LANDSLIDES
Landslides too small or obscure to map individually.

AREAS SUSCEPTIBLE TO DEBRIS FLOWS AND DEBRIS AVALANCHES
Primarily shallow, narrow ravines and chutes with accumulation of stony colluvium generally 10 ft. (3 m) or less in thickness; susceptible to rapid movement during intense rainfall. Most ravines and chutes designated show evidence of former debris flows and avalanches. Symbol & designates historical debris flow or debris avalanche.

AREAS SUSCEPTIBLE TO ROCKFALL
Steep, locally vertical, natural and man-made slopes and cliffs, 15 ft. (4.5 m) or more high; formed dominantly of sandstone, limestone, sandy shale, mudstone and claystone. Interbedded mudstone, claystone and shale weather rapidly leaving sandstone and limestone rock faces unsupported.

SOIL AND ROCK SUSCEPTIBLE TO LANDSLIDING
Soil and rock similar to that involved in landslides elsewhere in map area; primarily areas underlain by claystone, mudstone and shale associated with other rock types. Rock weathers rapidly on exposure forming clayey soil highly susceptible to sliding. Includes coves (U-shaped, shallow valleys) containing thick layers of clayey soil that are very susceptible to sliding where excavation breaks continuity of slope and where overloaded by artificial fill.

AREAS LEAST PRONE TO LANDSLIDES
Map areas in which no patterns or symbols are shown; primarily valley floors, ridge tops and broad benches; modification by excavation and fill may lead to local landslides.
